Balcony Observation Report Supplement to CA Civil Code 5551 Report

April 23, 2025

Windsong Sonoma Association

SSW Project Number: 241-044

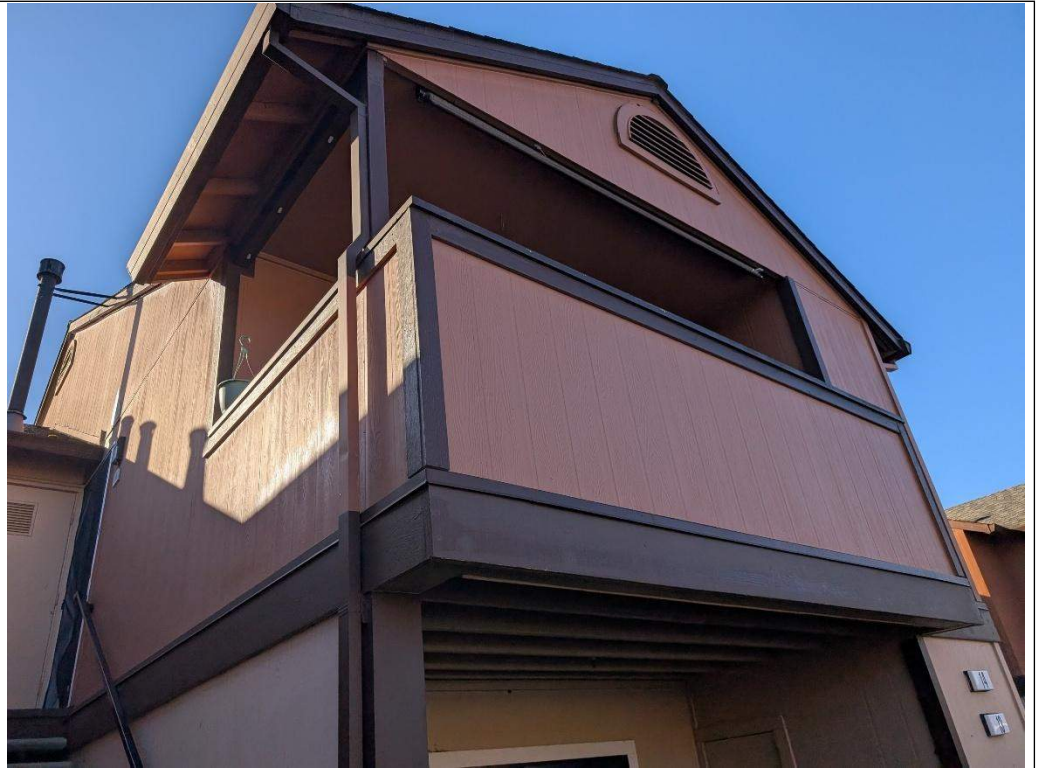
(Balcony at Unit 14)

1. Typical balcony with parapet guard walls. The primary joists are simply-supported and the framing is visible underneath (no soffit). The balconies have a drip-thru style water management strategy (no membrane).

The private balconies are well-protected by the generous overhang above.

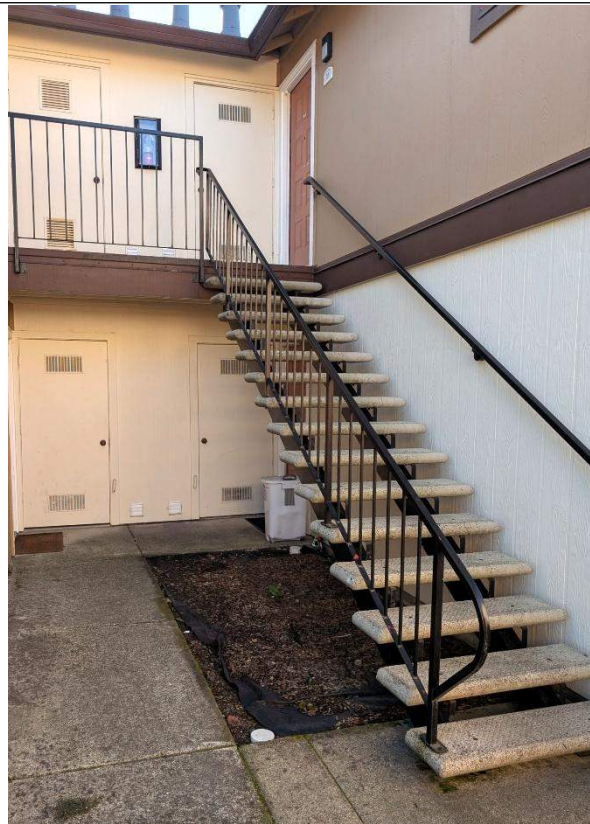
(Stairway & Landing for Units 26 & 28)

2. Typical stair and landing serving (2) second-floor units. Both elements are uncovered.

The stairs do not include any intermediate support and rely substantially on the wood framing for support.

The water management strategy for landings varied significantly and included drip-thru at some areas, a polymer modified cementitious coating at a few areas, and a protected membrane with edge metal and weeps at some areas.

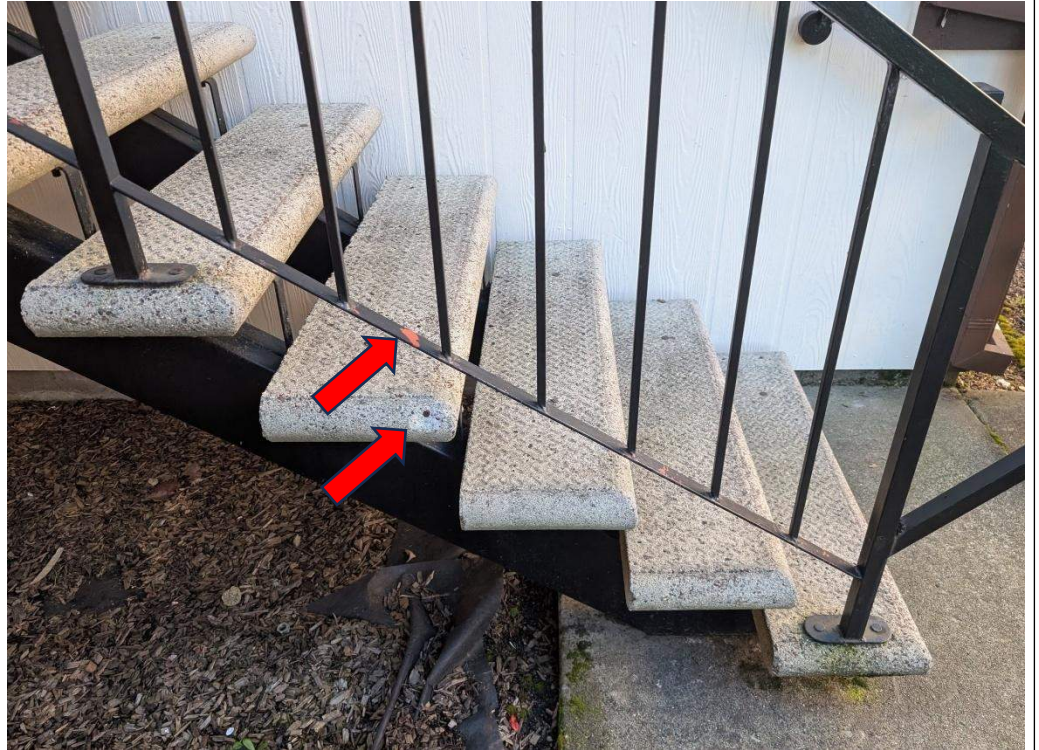
(Stairway for Units 26 & 28)

3. The stairs have open risers and pre-cast concrete treads attached to steel HSS double stringers. The metal guardrails are top-mounted. Guardrails with flaking paint should be repainted to avoid rusting. Some treads were also observed with spalled concrete.

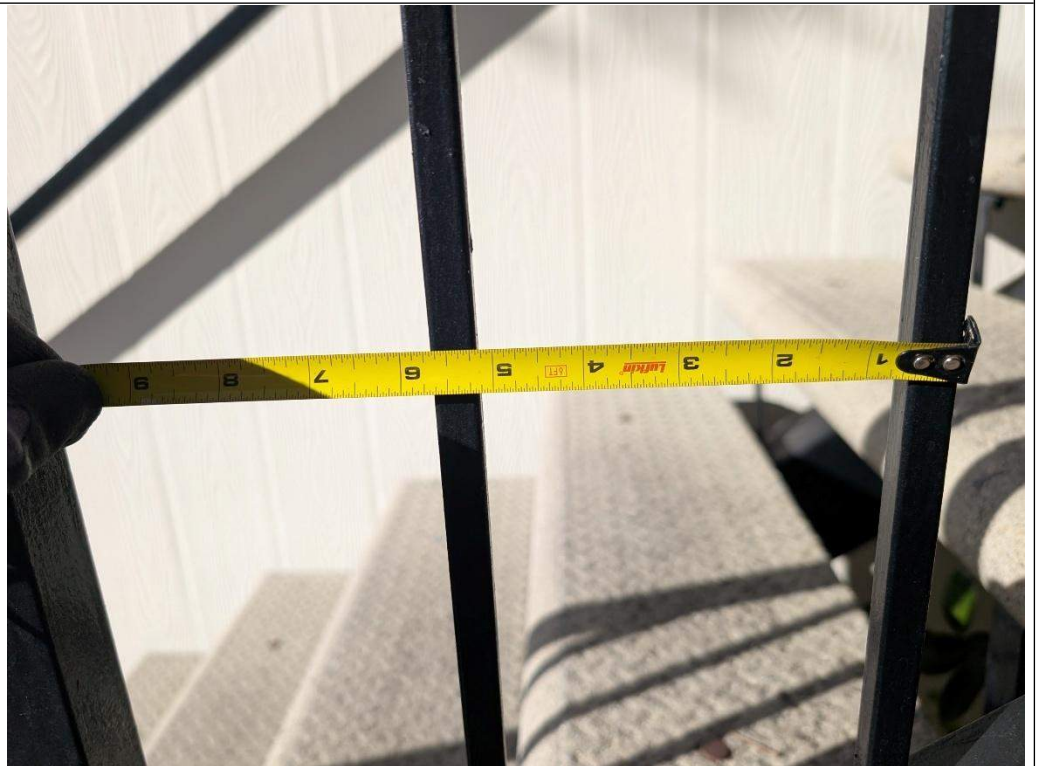
(Stairway for Units 18 & 20)

4. Stair baluster spacings exceed the code maximum of 4". This condition appears to be legal, non-conforming.

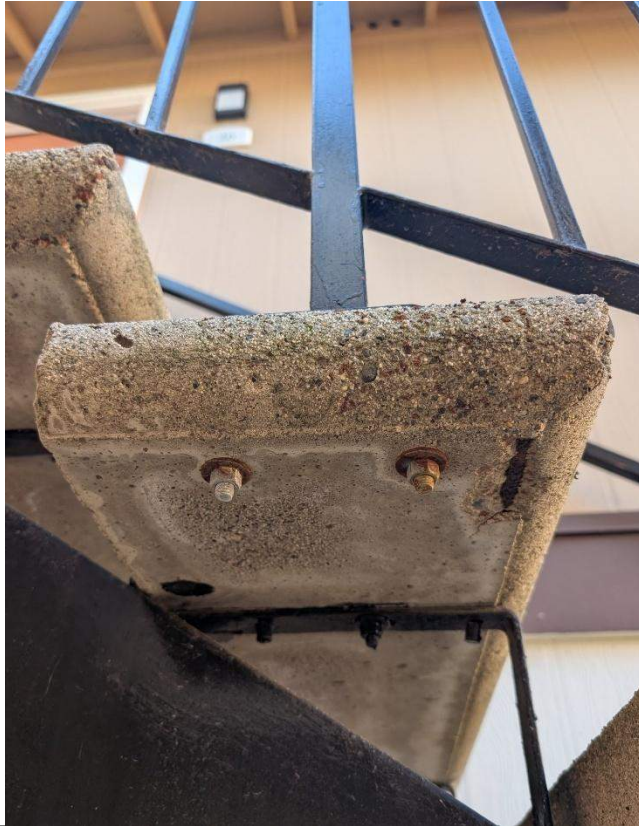
(Stairway for Units 26 & 28)

5. Some hardware, including the bolts shown, are beginning to rust and should be monitored. Here we can also see some exposed rebar on the underside of the tread.

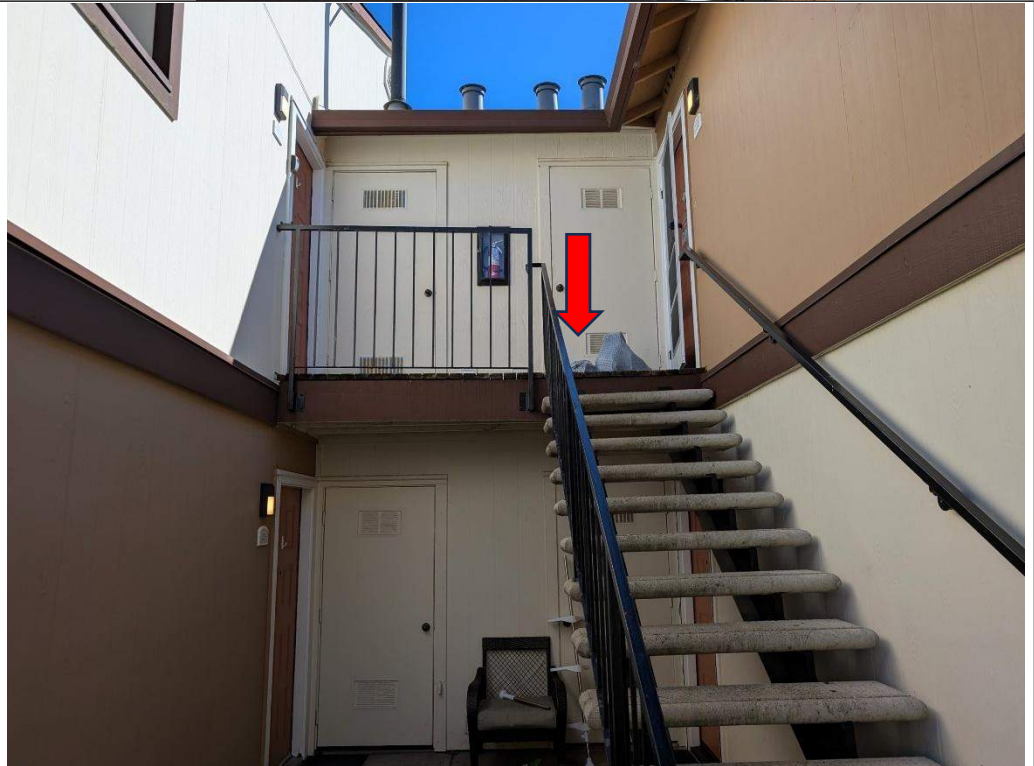
(Stairway & Landing for Units 214 & 216)

6. Despite the apparent sagging occurring at this stairway and landing, it is still considered to be in fair condition. We recommend re-leveling the stair stringers.

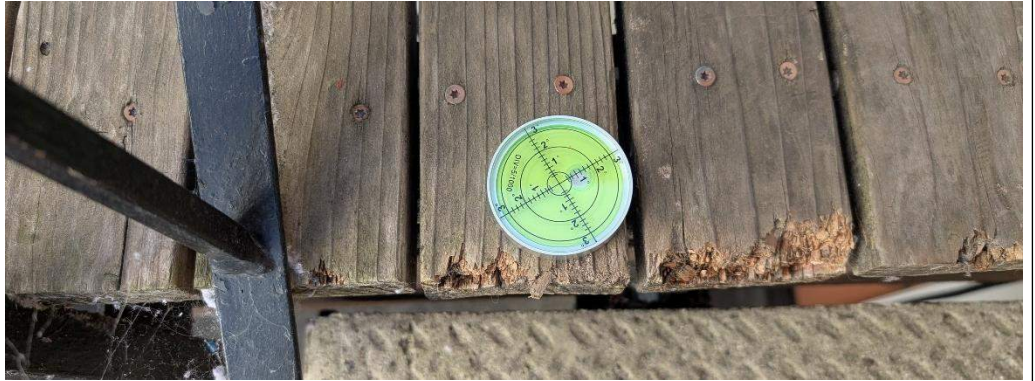
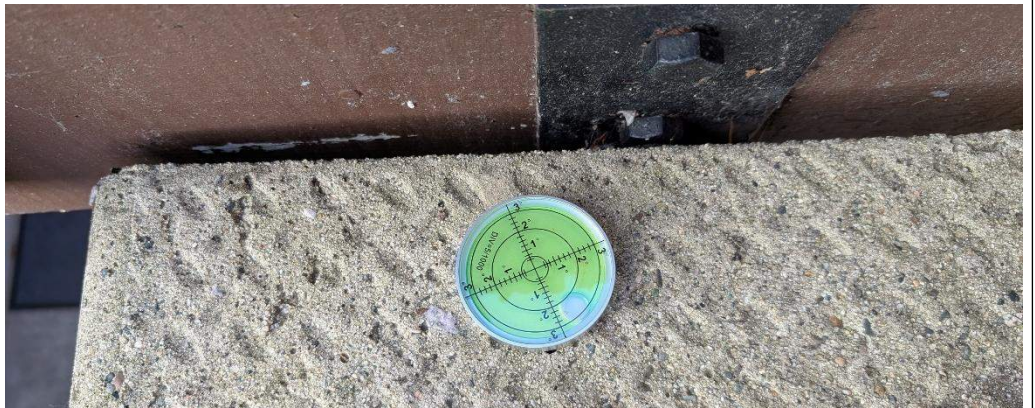
(Stairway & Landing for Units 214 & 216)

7. Currently, there is a discrepancy in the slope of the landing in comparison to the slope of the stairway.

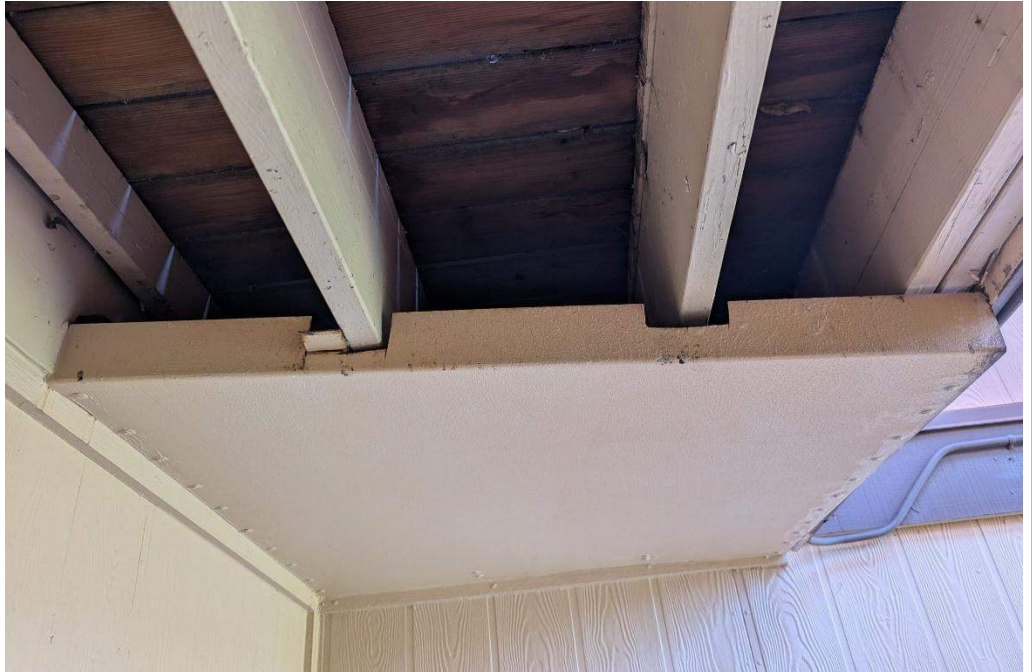
(Landing for Units 42 & 44)

9. A soffit has been installed above the entry way to Unit 43.

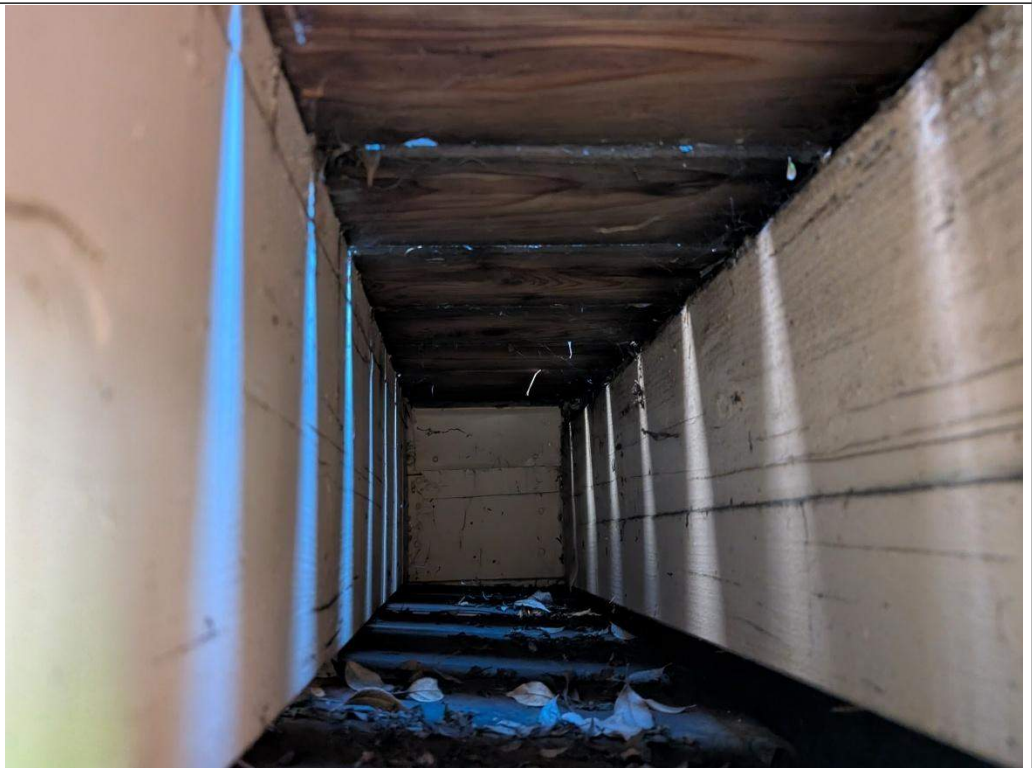
(Cavity of Landing for Units 42 & 44)

10. A view from within the cavity of the soffit built below the drip-thru boards. Debris is beginning to accumulate inside.

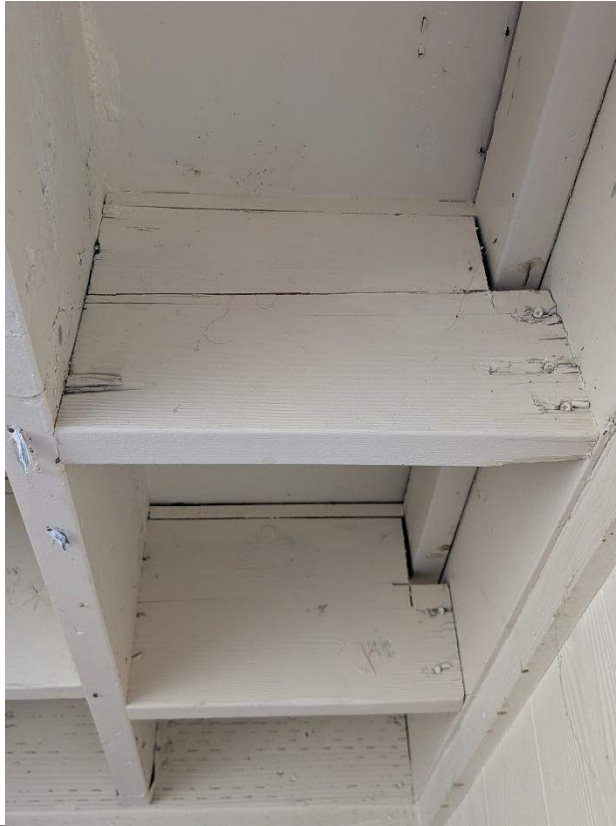
(Landing for Units 110 & 112)

11. The blocking has been notched to accommodate the existing nailers (for sheathing installation).

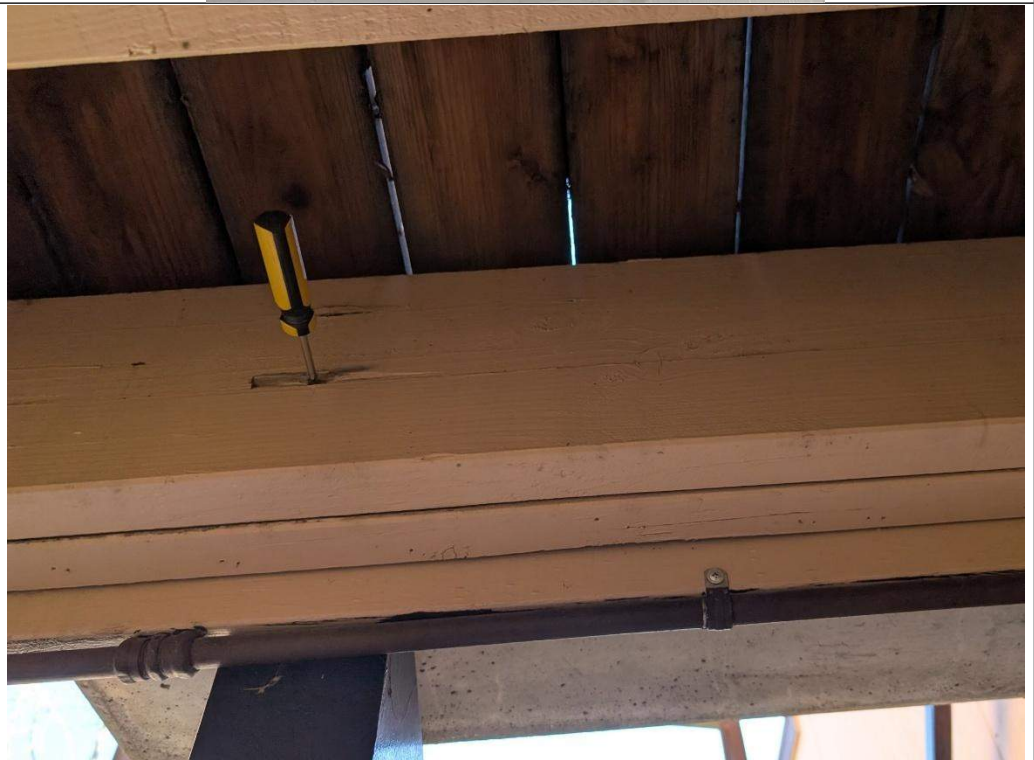
(Stairway & Landing for Units 42 & 44)

12. Although bolt holes were drilled, the double stringers of this stairway are attached via lags.

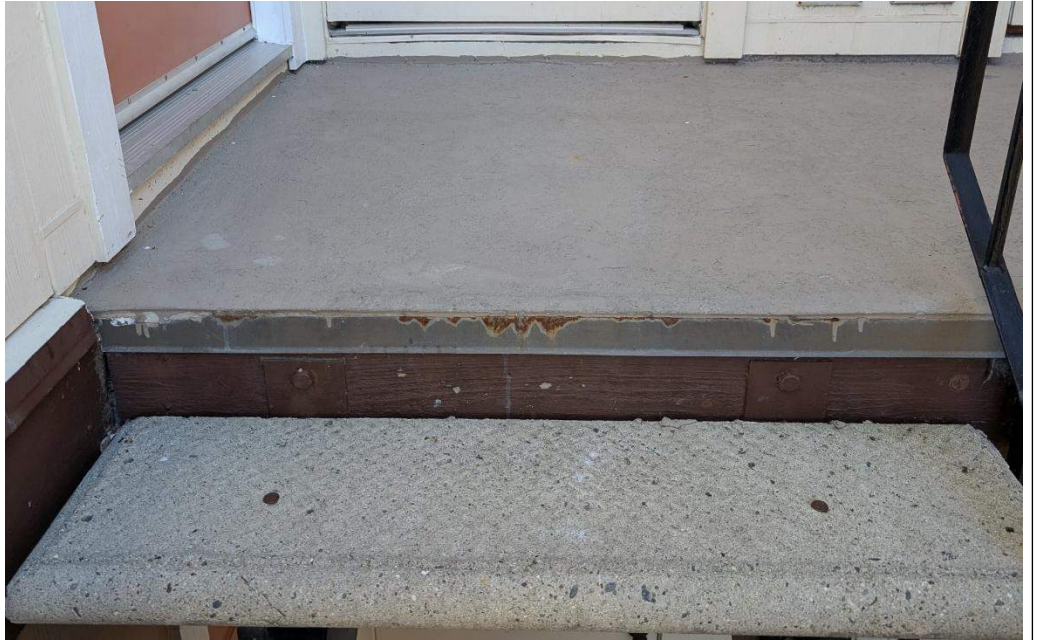
(Stairway & Landing for Units 110 & 112)

13. The cementitious coating on this landing has been painted over, but rust is still visible at the edge flashing.

This type of exposed membrane system often requires recoating every 5 to 7 years, according to industry standard recommendations.

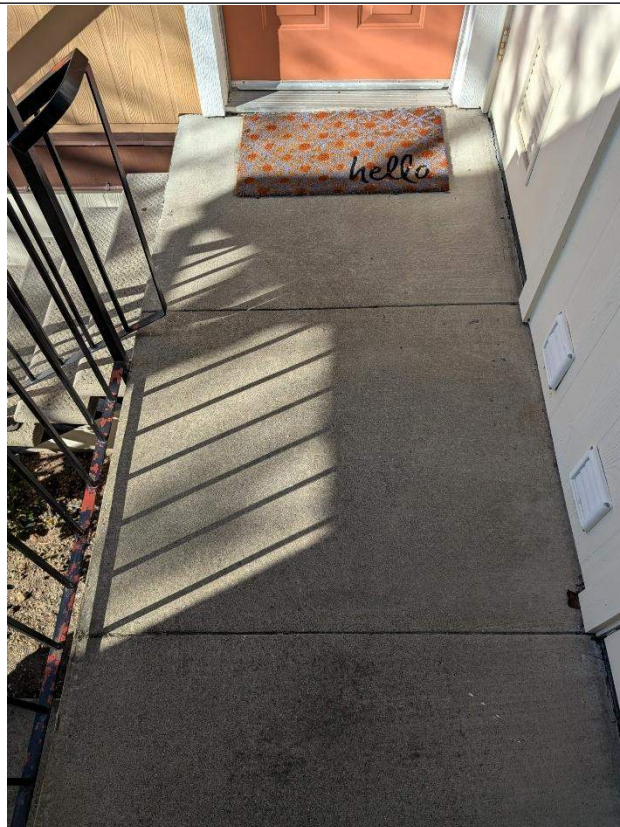
(Landing for Units 18 & 20)

14. Most landings at this complex have concrete toppings and utilize a 2-piece drip edge. In case of rain, we suspect that water would be unable to drain out because the weep holes are easily clogged.

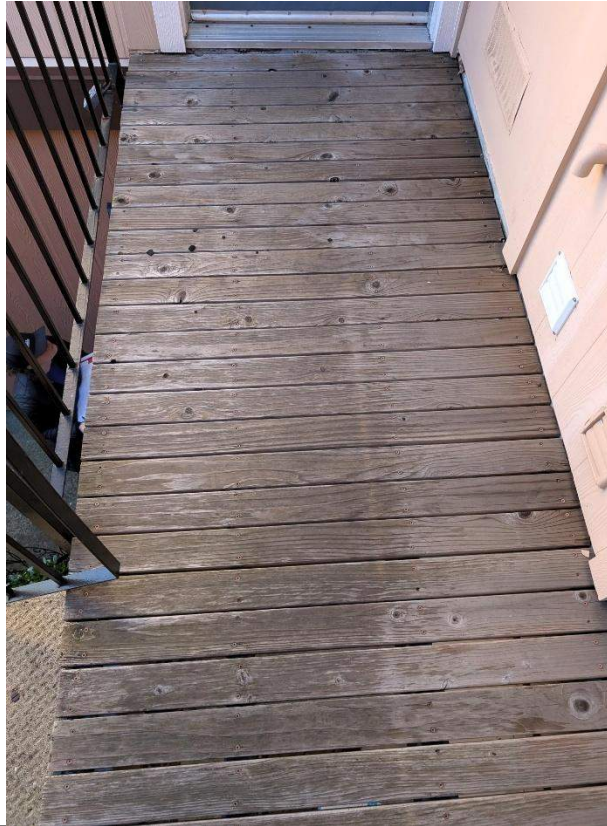
(Landing for Units 198 & 200)

15. There are some landings with a drip-thru deck. The wear on this surface is minor.

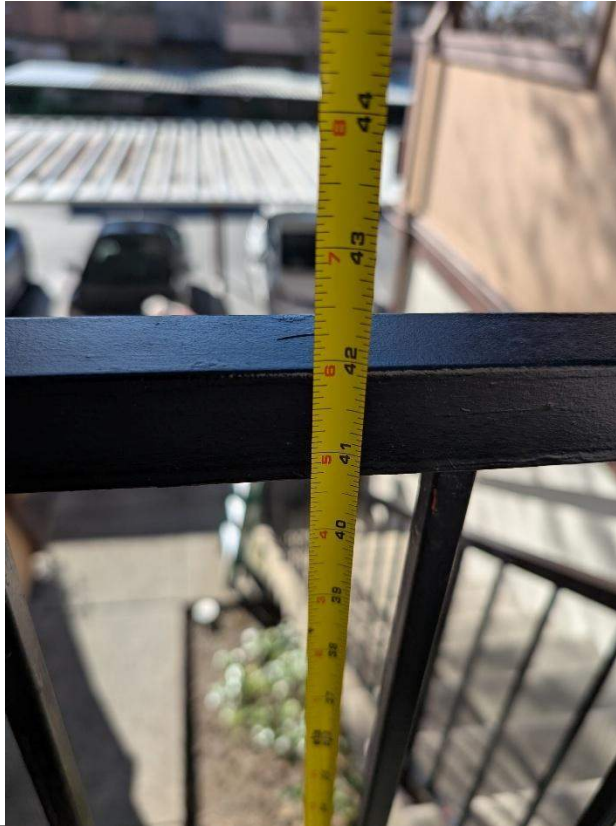
(Landing at Units 18 & 20)

17. The steel guardrails at landings appear to have sufficient height to meet current building codes.

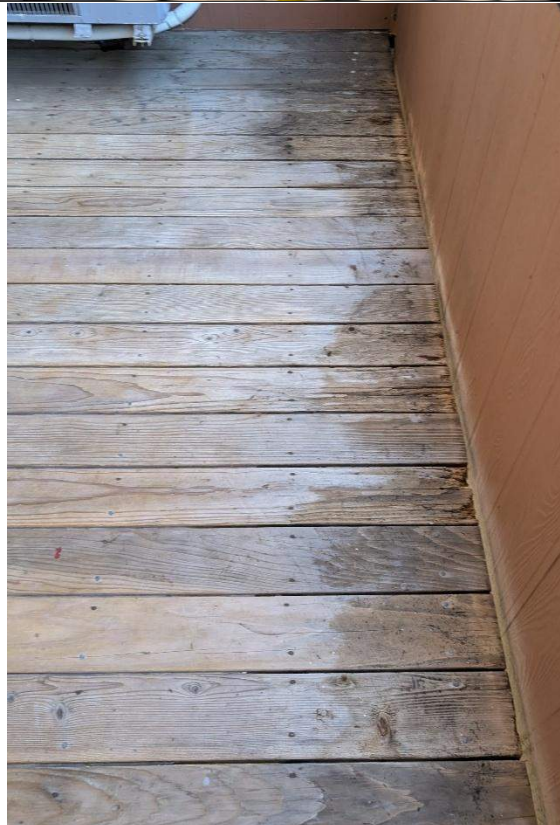
(Balcony at Unit 180)

18. In addition to the replacement of a joist and girder below, several deck boards need replacing. This balcony is considered to be in poor condition (based on framing observed below).

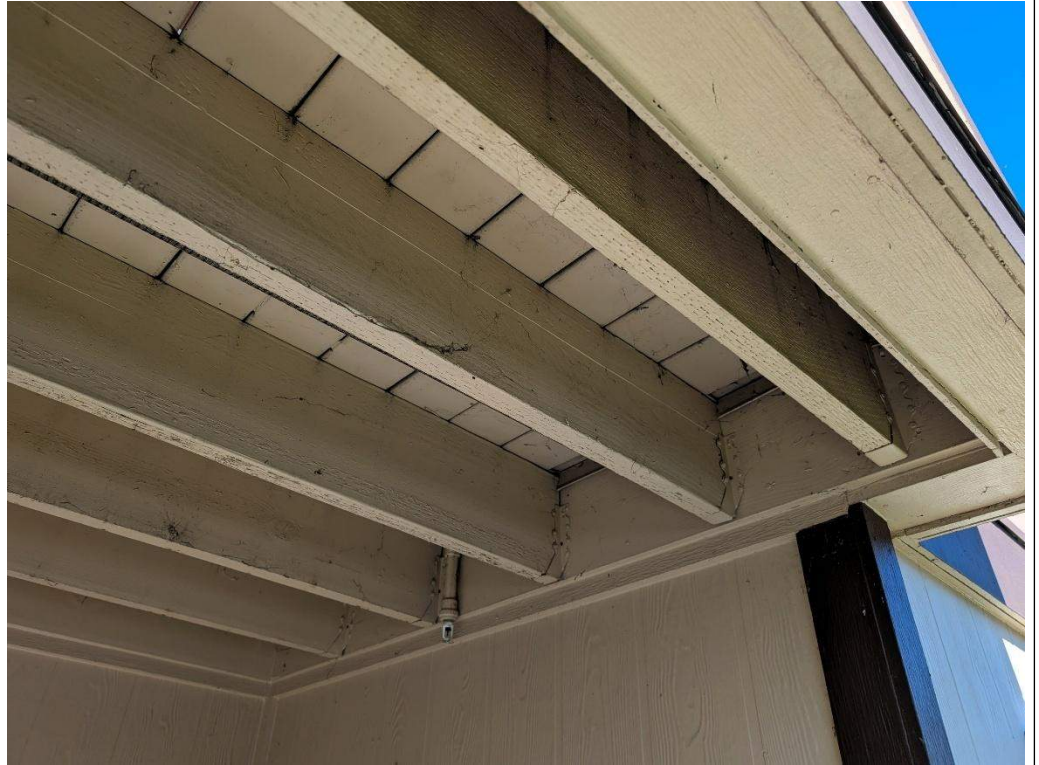
(Framing of Balcony at Unit 202)

19. Balconies were constructed using a combination of treated and untreated wood. Although there were many different ways in which treated wood was incorporated (or not), the two joists closest to the edge of the balcony were typically treated.

Note the short cantilever of the edge girder.

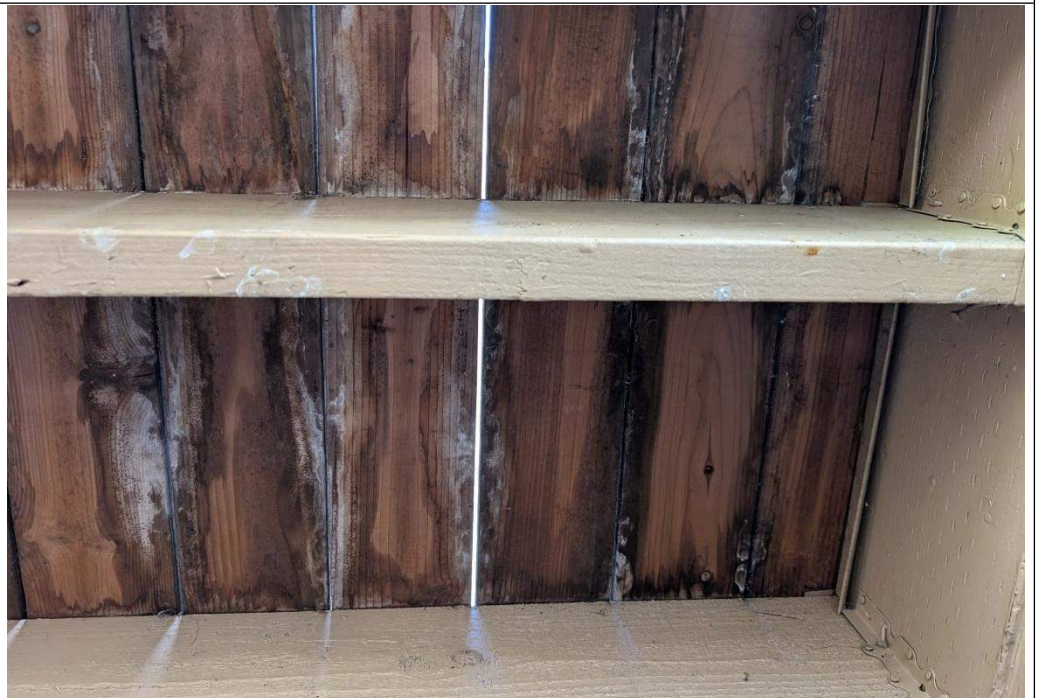
(Framing of Balcony at Unit 214)

20. Deck boards with moderate staining and minor rot.

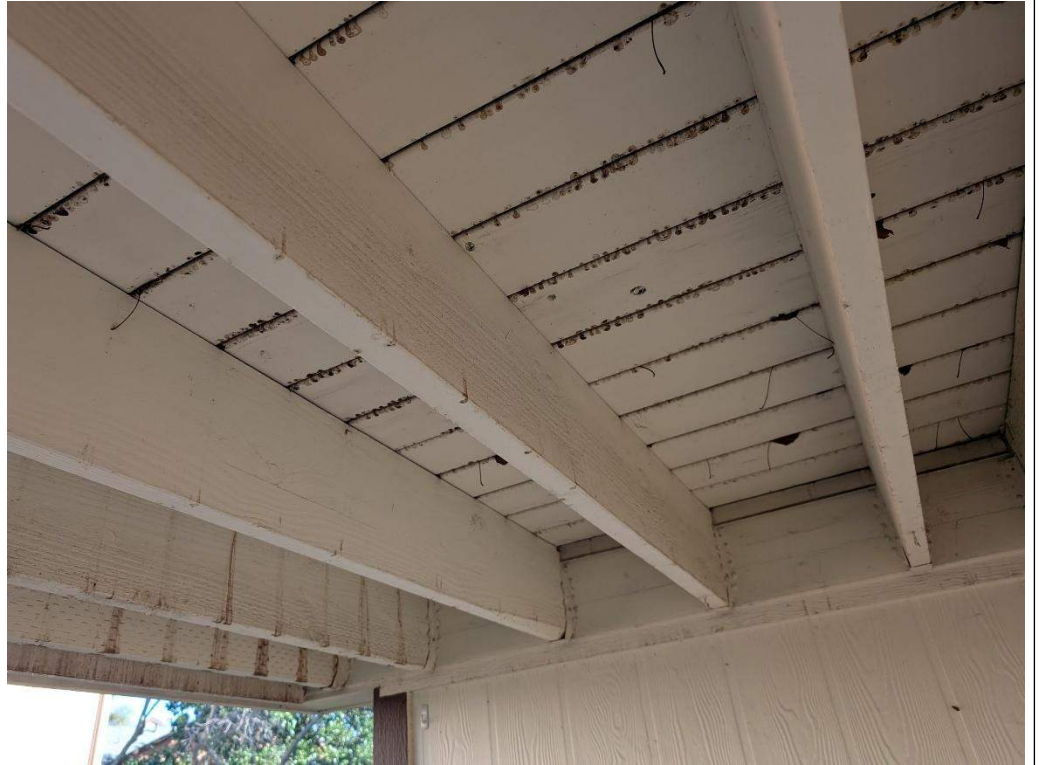
(Framing of Balcony at Unit 26)

21. Severe staining on deck boards and some joists, most likely due to overwatering plants. We recommend clearing debris from the deck surface.

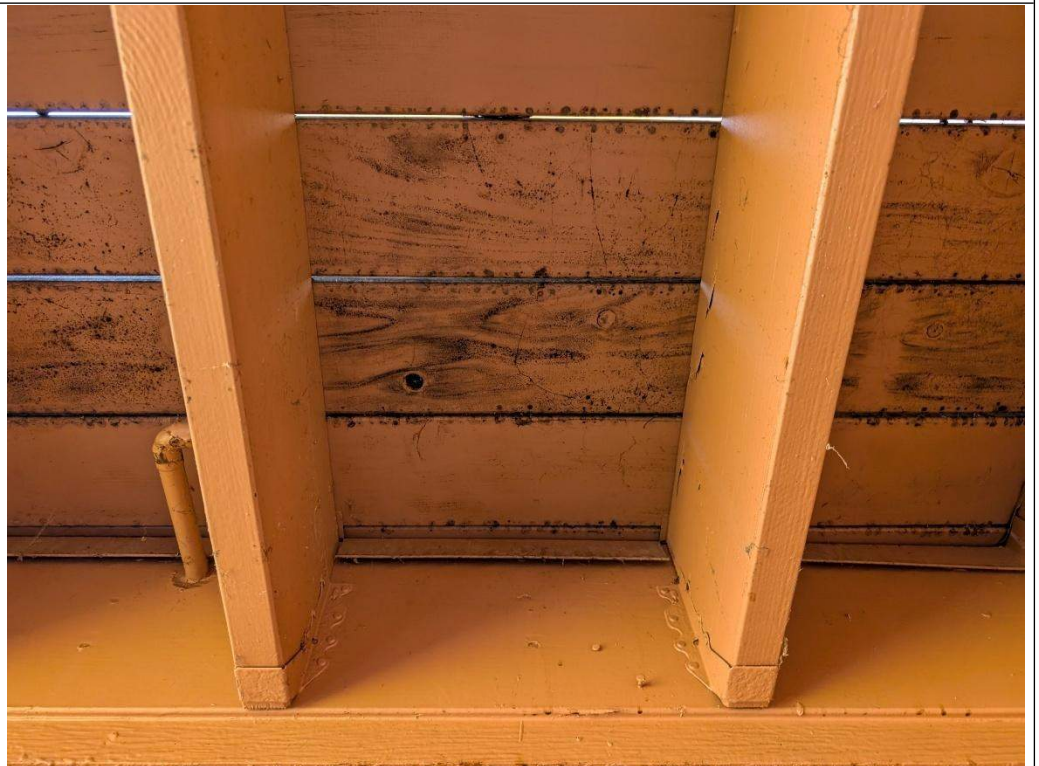
(Framing of Balcony at Unit 118)

22. Several balconies with painted deck boards displayed peculiar patterns of staining, almost like a patina. It is possible that this may be the result of a chemical reaction between already stained deck boards and the paint applied to them.

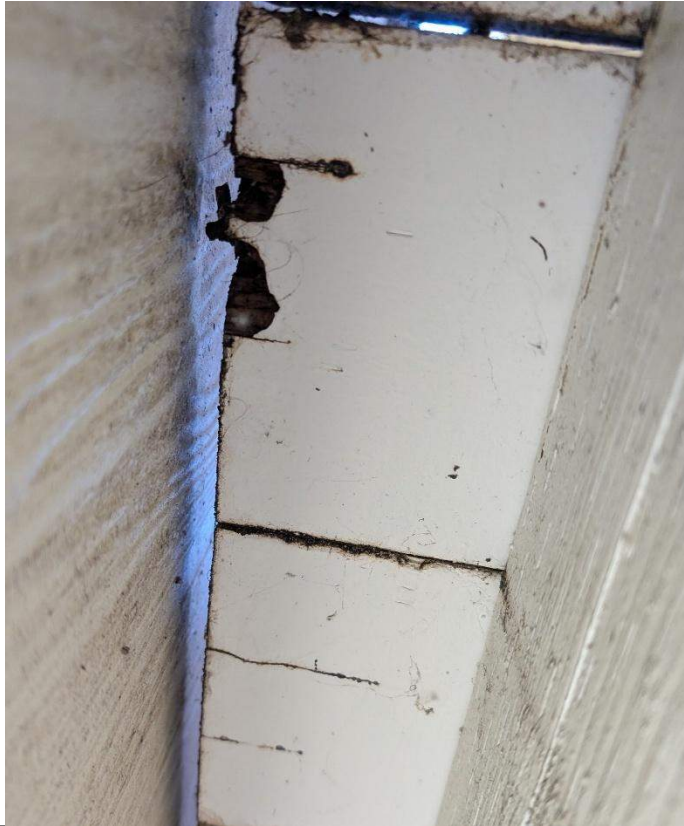
(Framing of Balcony at Unit 150)

23. The end of the deck board is rotting out and will need to be replaced.

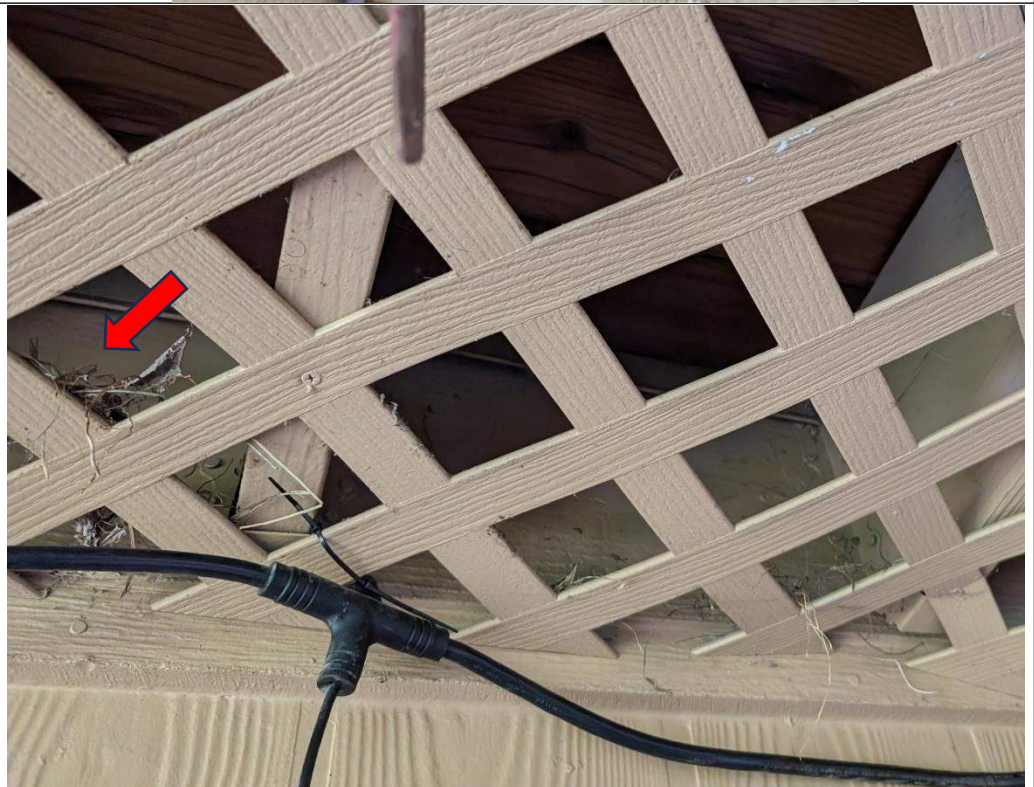
(Framing of Balcony at Unit 212)

24. A lattice soffit has been installed below the drip-thru balcony. Bird nests should be cleared.

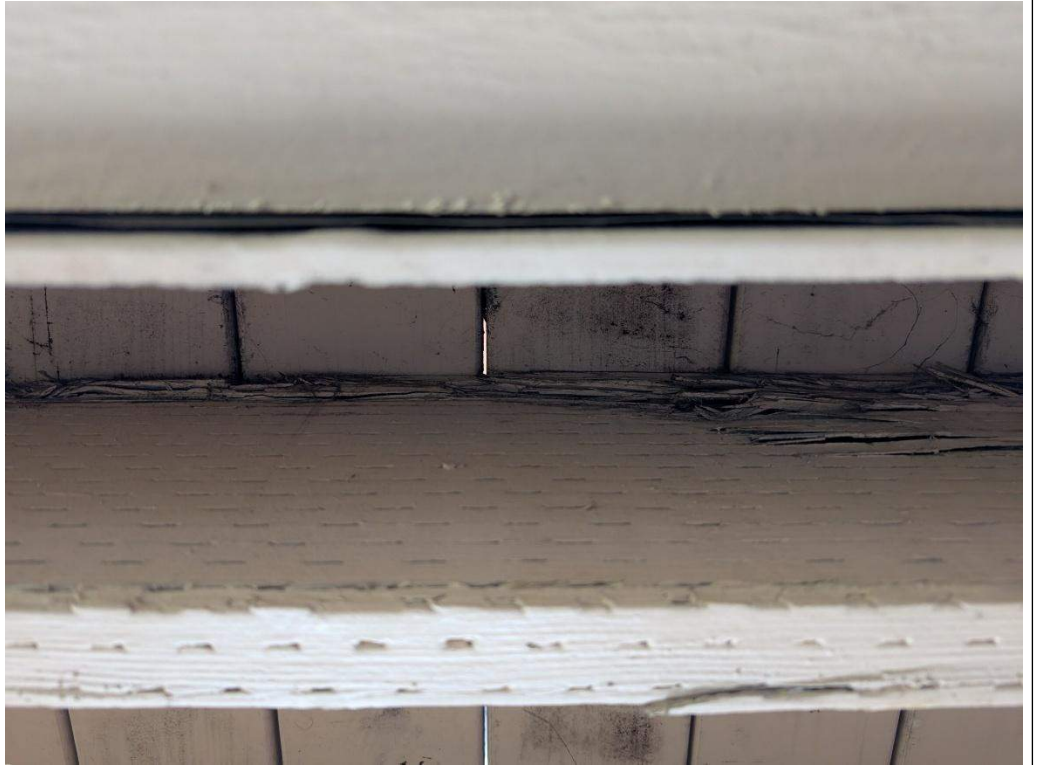
(Framing of Balcony at Unit 128)

25. Despite being pressure treated, this joist has begun to rot and will require replacement.

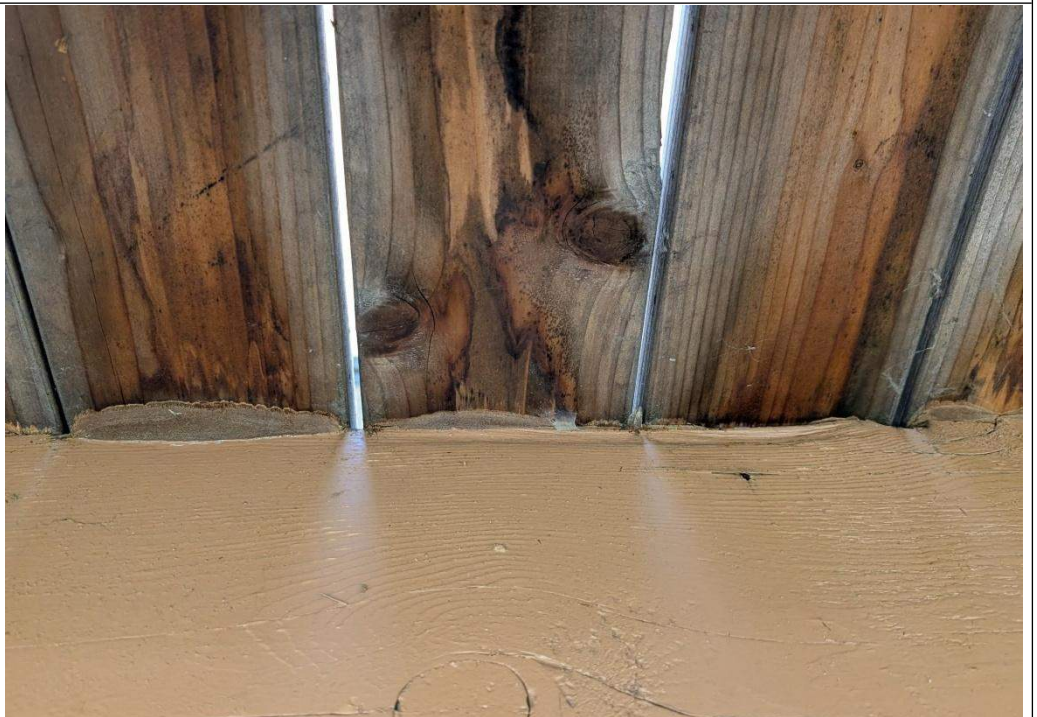
(Framing of Balcony at Unit 206)

26. Growth has begun to form between the deck boards and the adjoining joist.

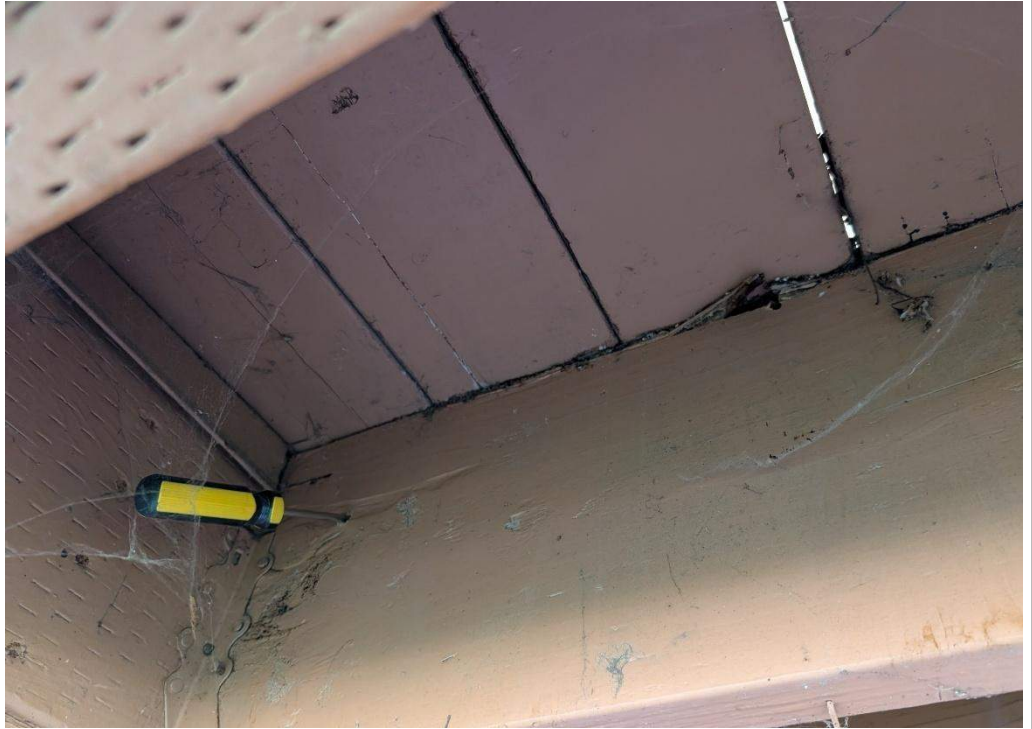
(Framing of Balcony at Unit 130)

27. Rot has caused the wooden joist to become soft and lose structural integrity.

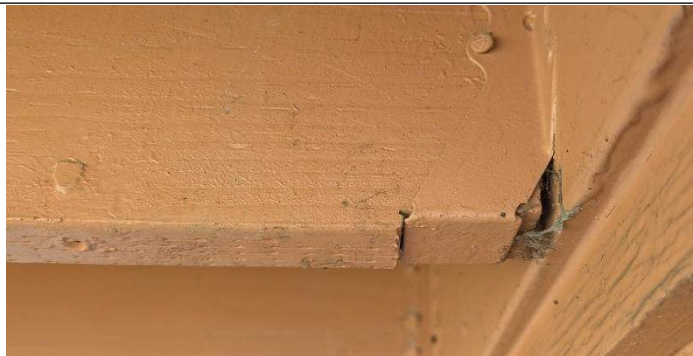
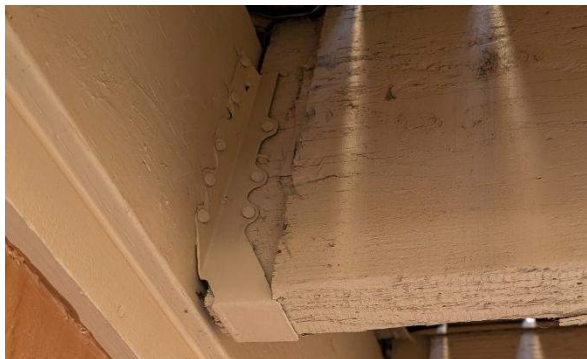
28. At several balconies, joists were notched in various ways to fit the accompanying hardware.

(Above: Framing of Balcony at Unit 118)

(Below: Framing of Balcony at Unit 198)

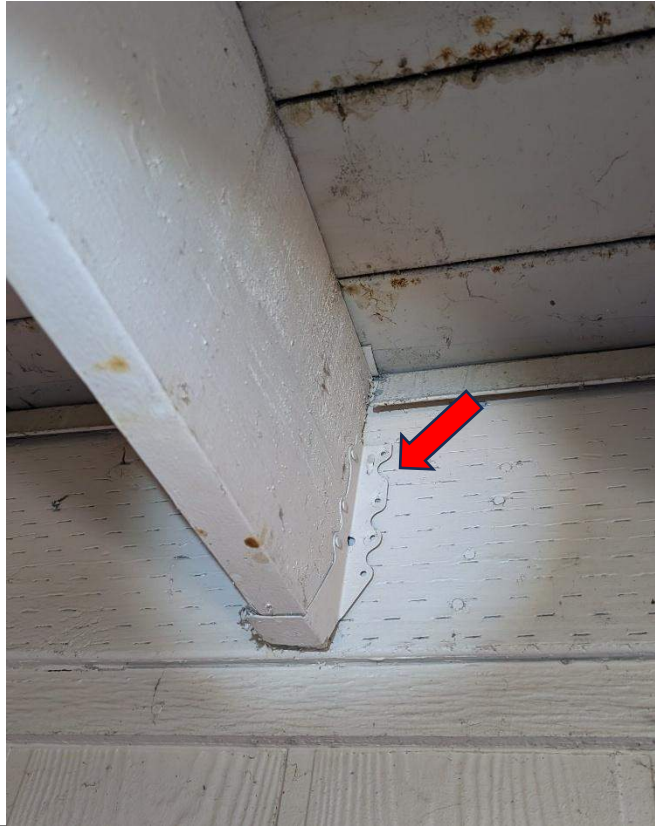
(Framing of Balcony at Unit 190)

29. The hanger holding this joist has not been secured properly to the girder. Nails should be installed to secure its placement.

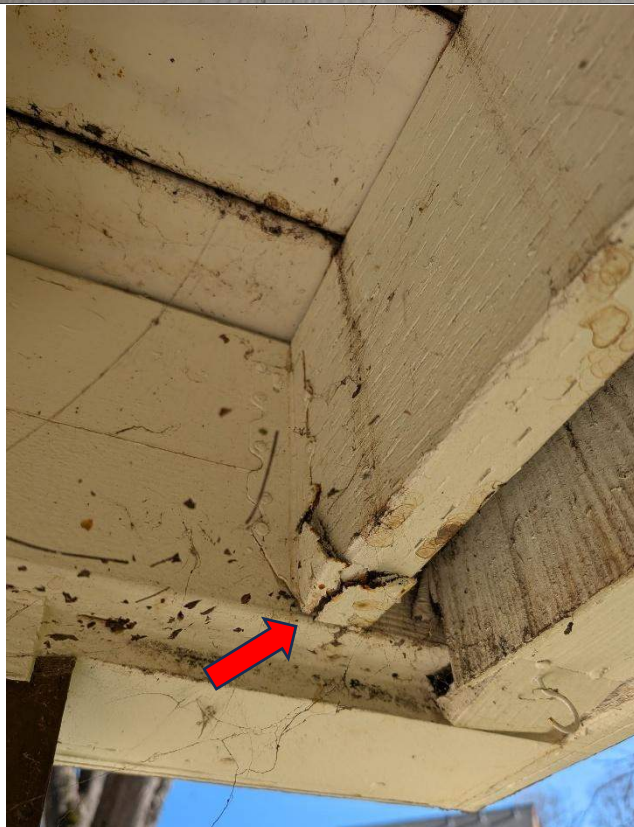
(Framing of Balcony at Unit 52)

30. The hanger holding the joist is rusted and damaged. It should be replaced.

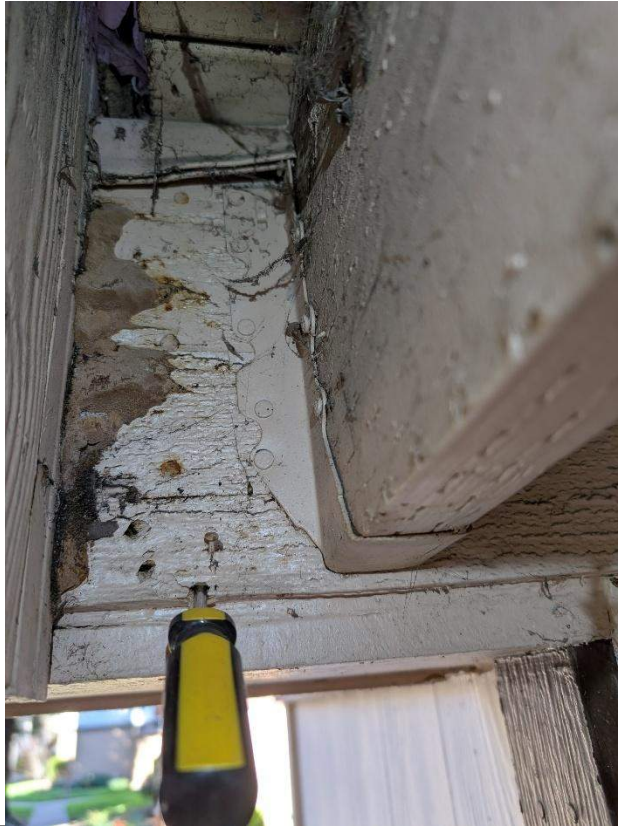
(Framing of Balcony at Unit 190)

31. The girder is rotted and will need to be replaced.

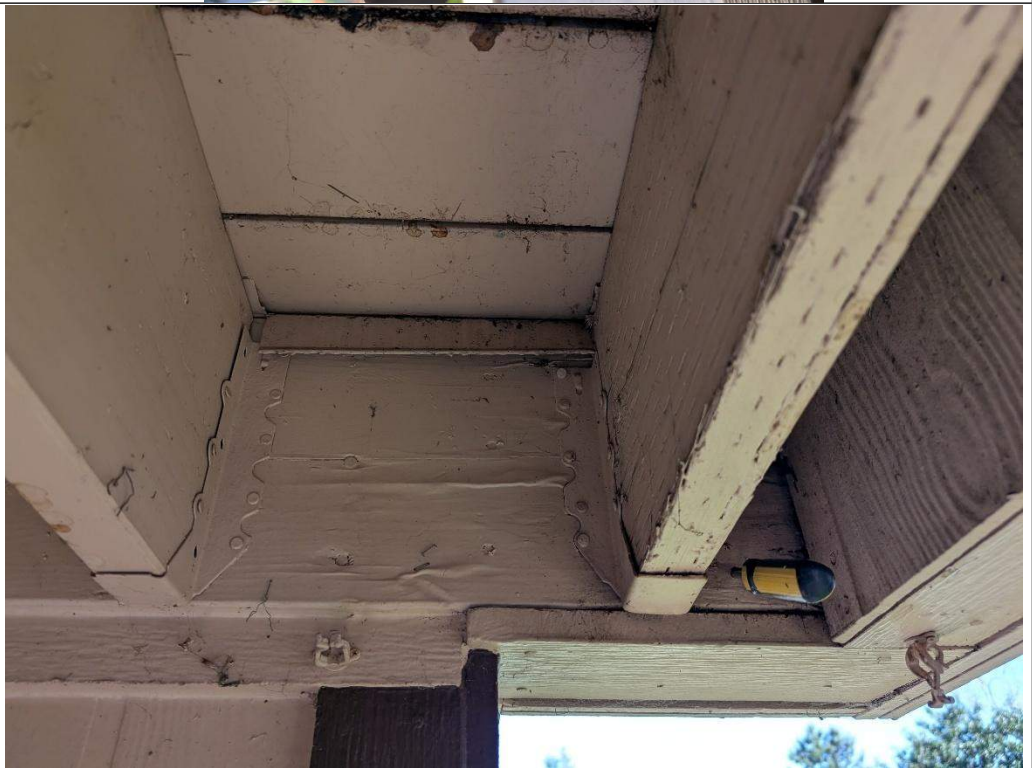
(Framing of Balcony at Unit 74)

32. Bubbling paint can be another sign of rot damage, such as with this girder.
